**CANADIAN FORCES  
FLIGHT SAFETY INVESTIGATION REPORT (FSIR)**

**FINAL REPORT**

**FILE NUMBER:** 1010-C-GCSD (DFS 2-3)  
**DATE OF REPORT:** 22 March 2006

**AIRCRAFT TYPE:** Schweizer 2-33A Glider  
**DATE/TIME:** 141847Z August 2003  
**LOCATION:** Debert Airport, Debert, Nova Scotia  
**CATEGORY:** "A" Category Accident

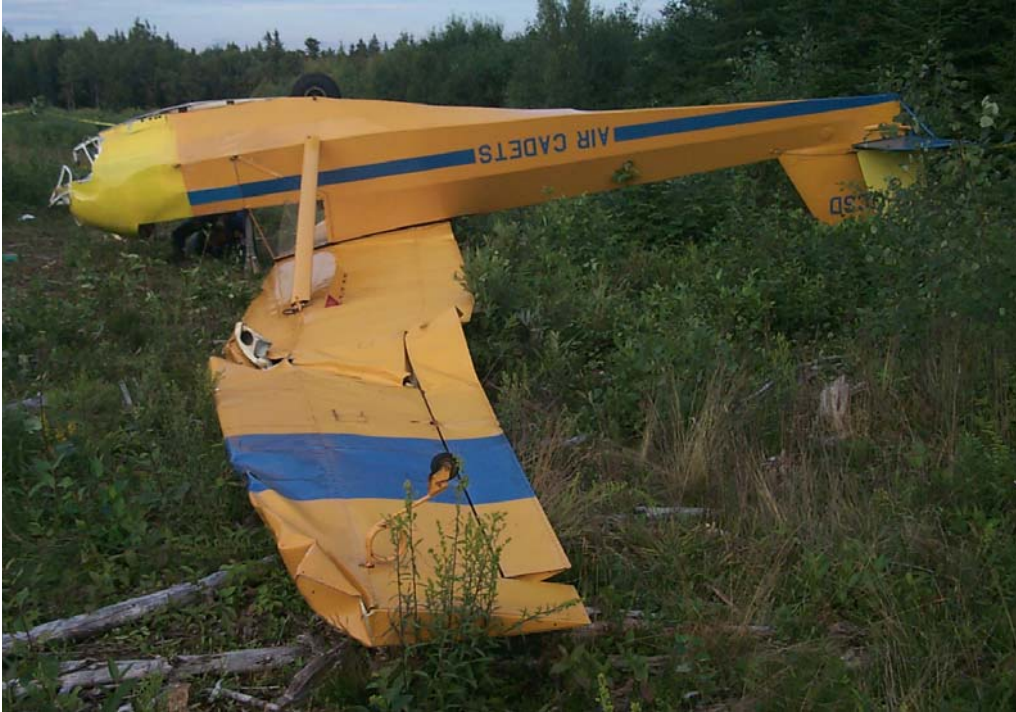
Photo 1: Final Resting Place

The glider sustained "A" category damage (Photo 1).

The impact site was within the airfield boundary approximately 700 meters from the approach end of runway 34 and beside a small access road just infield of a tall stand of trees. The left wing outrigger wheel was found at the base of the impact tree, 29 meters from the wreckage. The nose and wing ground impact scars were easily discernable and within a few meters of the glider's final resting point, indicating a near vertical ground impact; this was consistent with the glider's significant nose damage.

wing and nose first, in an inverted attitude, bounced backwards by about 5 ft, and came to rest on its back.

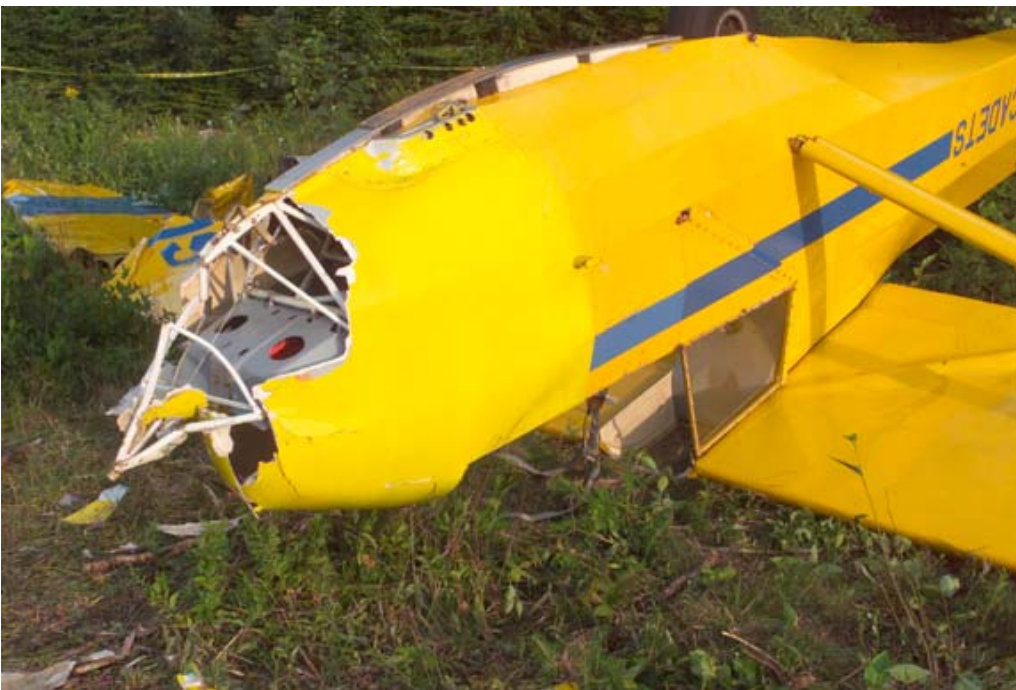
Photo 2: Nose Damage

The outboard portion of the left wing was torn from the rest of the wing due to the initial tree impact forces. The right wing suffered severe ground impact damage. The glider's nose was pushed in and shattered (Photo 2) and the vertical stabilizer was severely crushed.
